**Re: Grand Rapids IRA Civic Center – West Venue Roof Capacity Review
NCE Job No. 17-665**

A STRUCTURAL REPORT on the I.R.A. CIVIC CENTER WEST VENUE ROOF'S BOW STRING TRUSS MEMBER FRACTURE

**Re: Grand Rapids IRA Civic Center – West Venue Roof – Truss Web Failure
NCE Job No. 17-665**

**Re: Grand Rapids IRA Civic Center – West Venue Roof – Truss Web Member Repair
NCE Job No. 17-665**

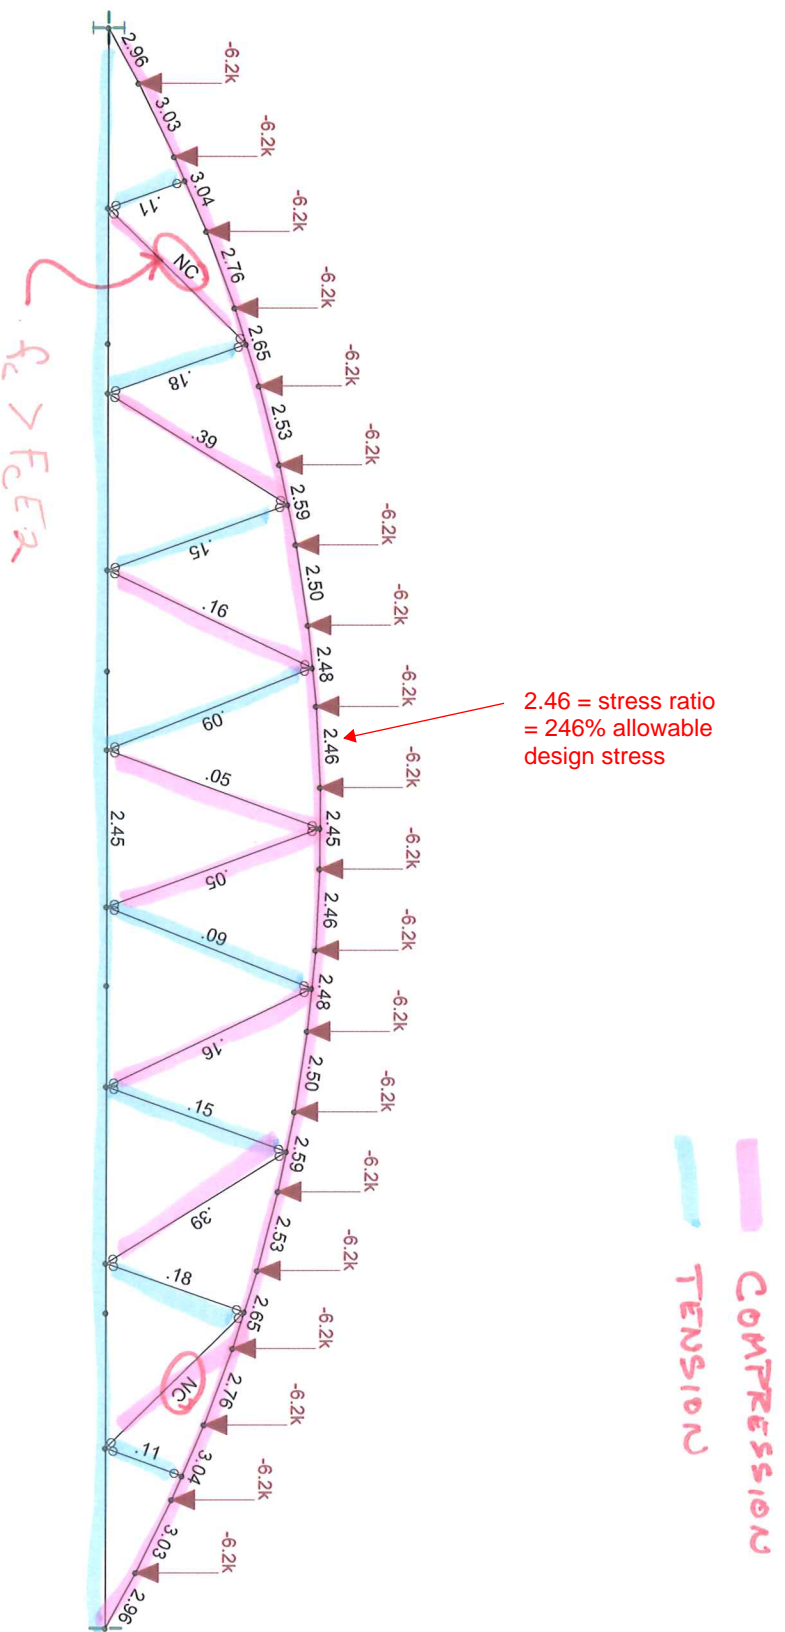
NCE		SK - 2
RTT	G.R. IRA Truss	Oct 20, 2017 at 11:02 AM
17-665	Current Snow Load = 46 PSF	17-665_Truss.r3d

3. The required uniform snow load for this building is now 46 psf. (*an increase of 53% compared to 30 psf as would be appropriate in the 1980s.*)
4. The current required unbalanced design snow load for this roof structure is approximately 92 psf maximum near the eave to 23 psf at the ridge.
[Engineers Note: Measured, snow density measurements generally vary from 15 pcf to nearly 28 pcf which means that current 46 psf design load is approximately 2 to 3 feet of snow]

Member Code Checks Displayed
Loads: BLC 2, Uniform Snow
Results for LC 2, Dead + Snow

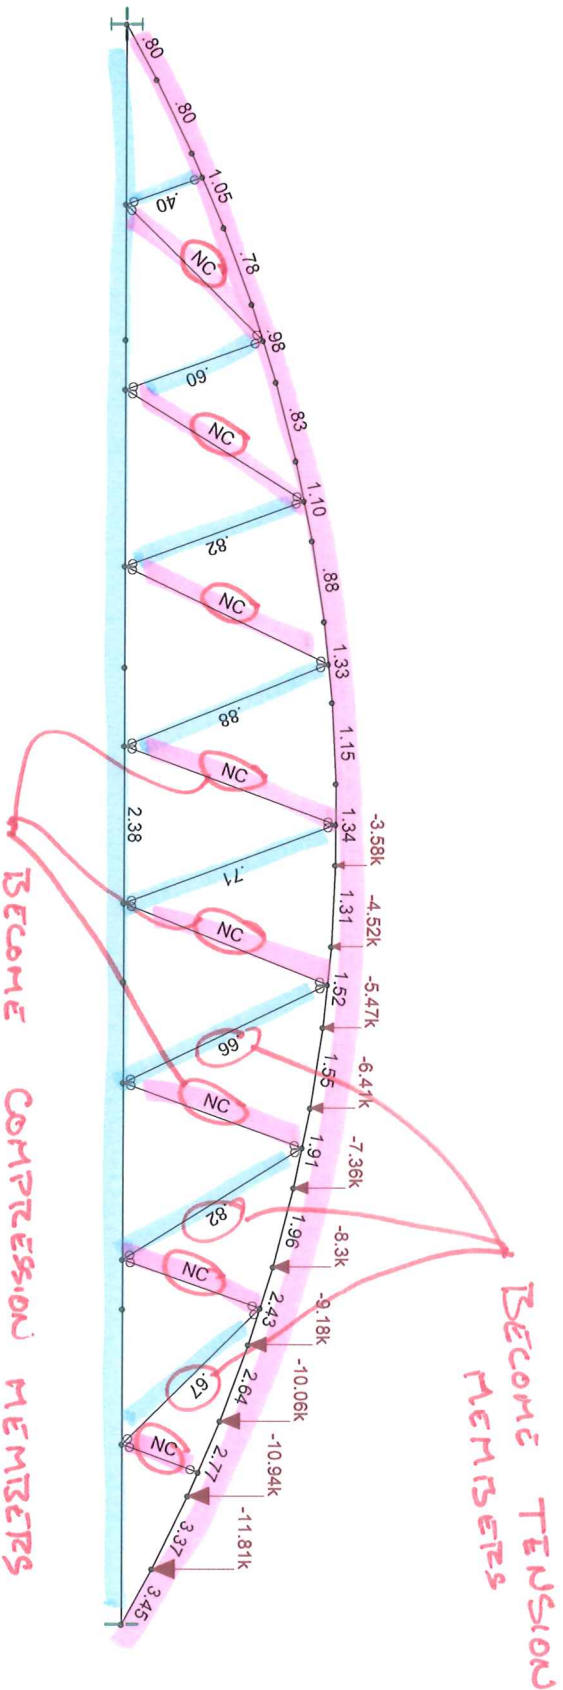
SK - 4

Member Code Checks Displayed
Loads: BLC 3, Unbalanced Snow
Results for LC 3, Dead + Unbalanced

G.R. IRA Truss
Unbalanced Snow Load w/ Uniform Snow = 46 PSF

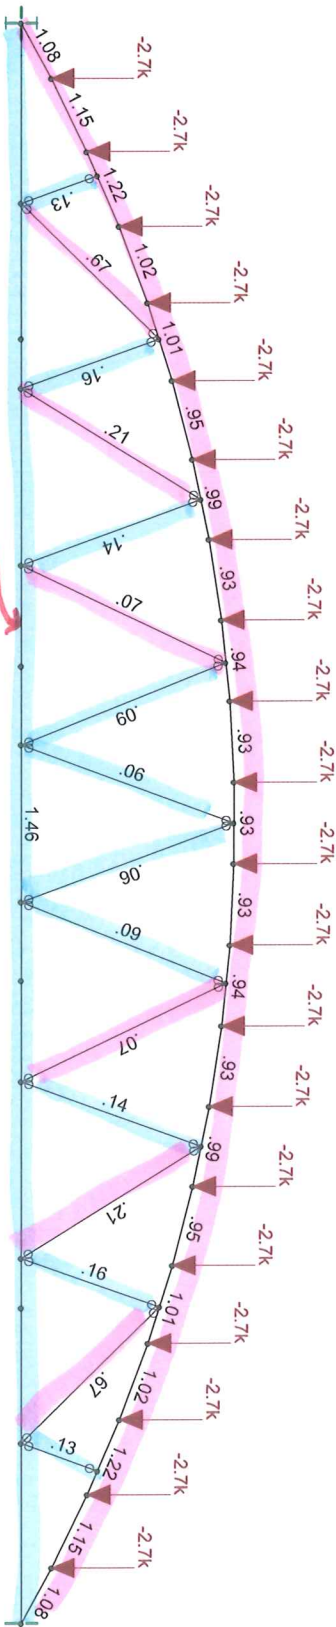
SK - 3

2. The 1962 Roof Trusses have a uniform snow load design capacity of approximately 20 psf.
3. The 1980's era roof trusses have a uniform snow load design capacity of approximately 30 psf.
4. Under unbalanced snow loading, several slender truss web members change from tension members to compression members, when this occurs, the truss can support only a design load of 15 psf over one half of the truss.
5. Connections: The connection capacity generally follows the member capacity, in other words the 1962 truss appears to have been professionally designed for 20 psf and the 1982 truss appears to have been professionally designed for 30 psf (both for uniform loading only)

Member Code Checks Displayed
Loads: BLC 4, Snow Capacity
Results for LC 4, Dead + Snow Load Capacity

Uniform Snow Load @ 20 PSF

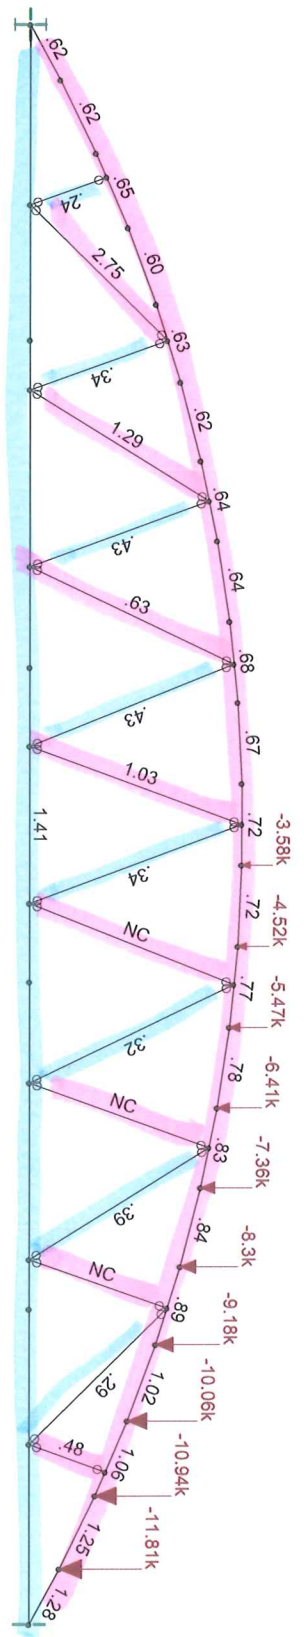
SK - 5

Member Code Checks Displayed
 Loads: BLC 3, Unbalanced Snow
 Results for LC 5, Dead + Unbalanced Snow @ Capacity

Unbalanced Snow w/ Uniform Snow Load = 20 PSF

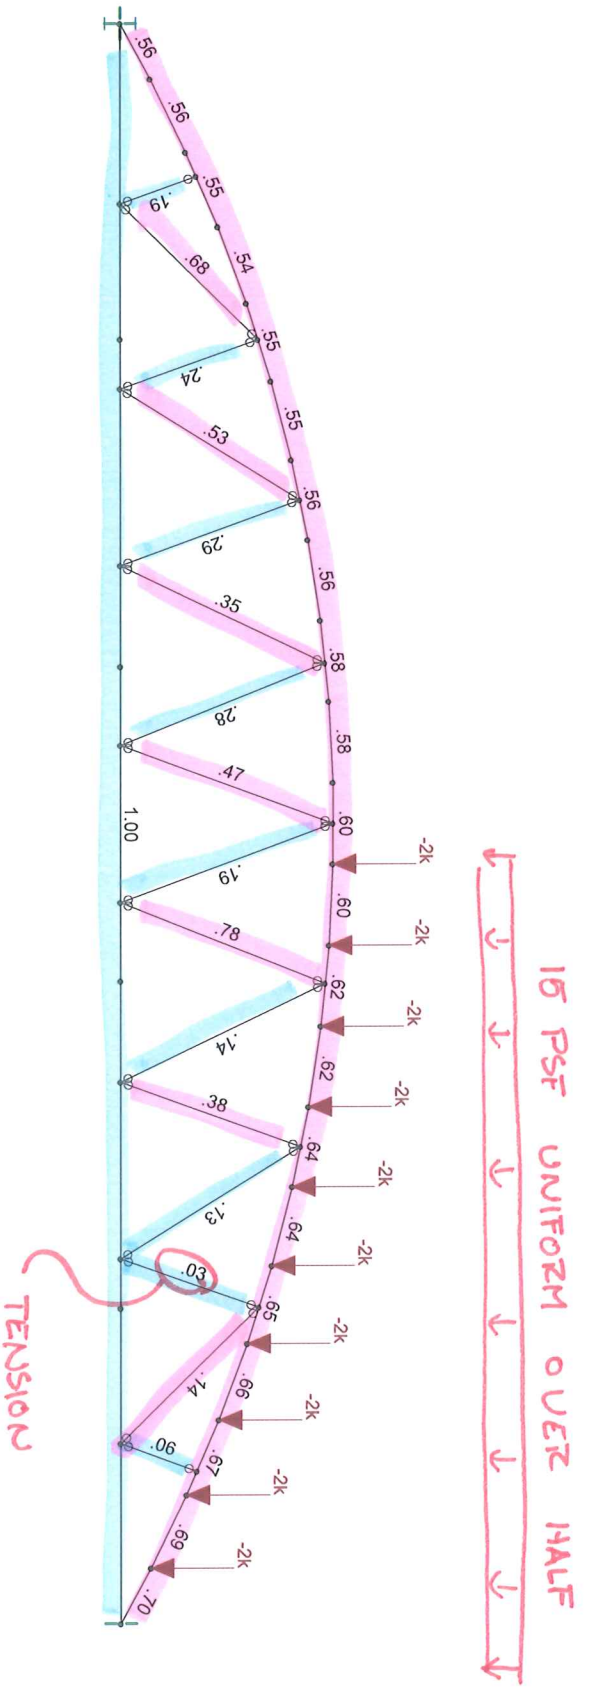
NCE		SK - 6
RTT	G.R. IRA Truss	Oct 20, 2017 at 11:10 AM
17-665	Uniform "Unbalanced" Snow @ 15 PSF Over Half of Truss	17-665_Truss.r3d

Member Code Checks Displayed
Loads: BLC 5, Reduced Unbalanced
Results for LC 6, Dead + Unbalanced Snow Reduced

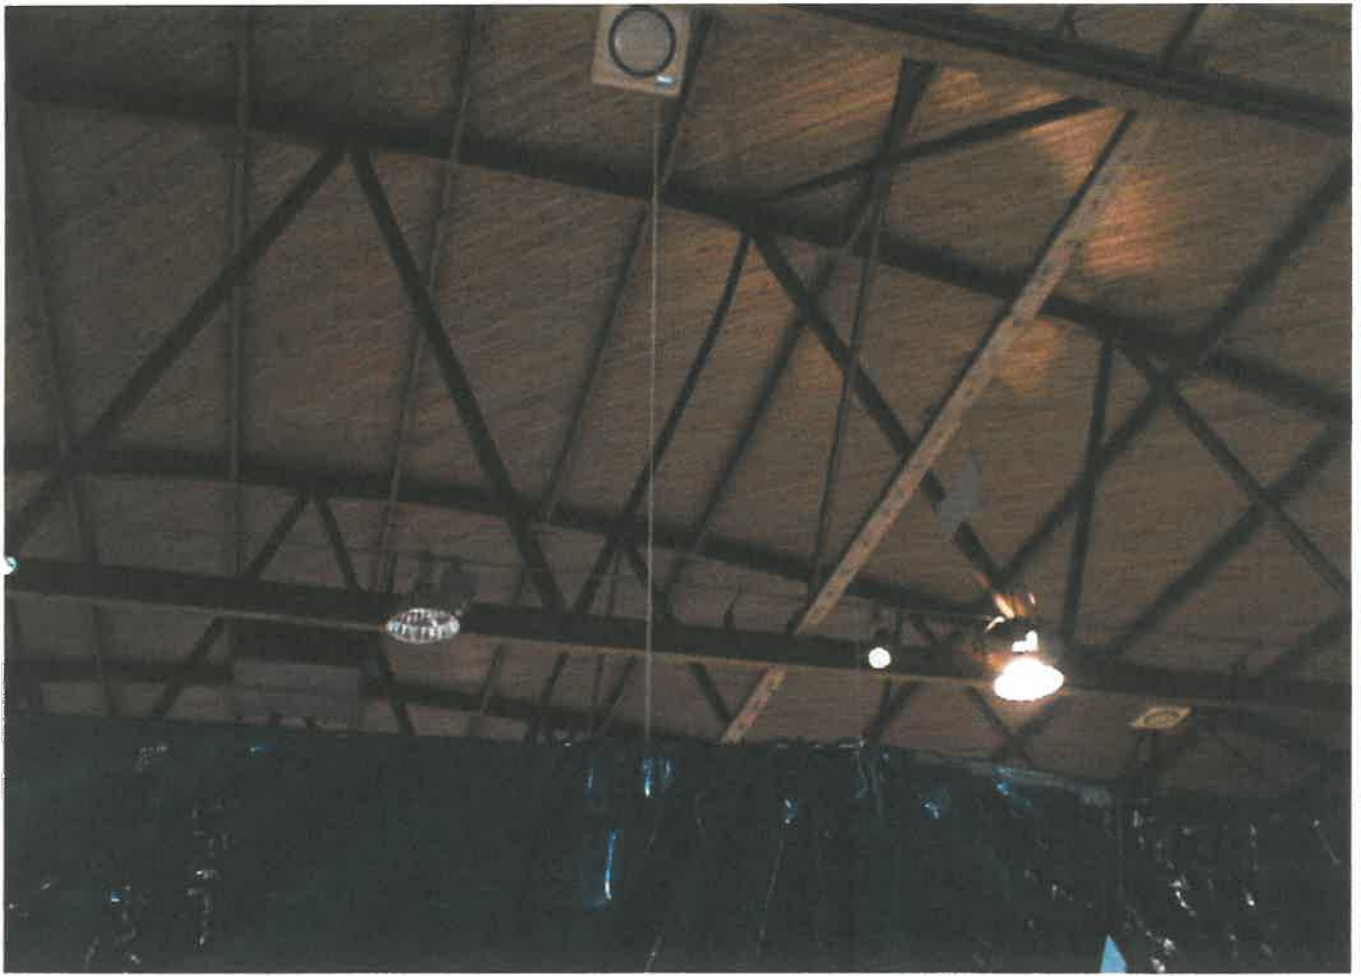
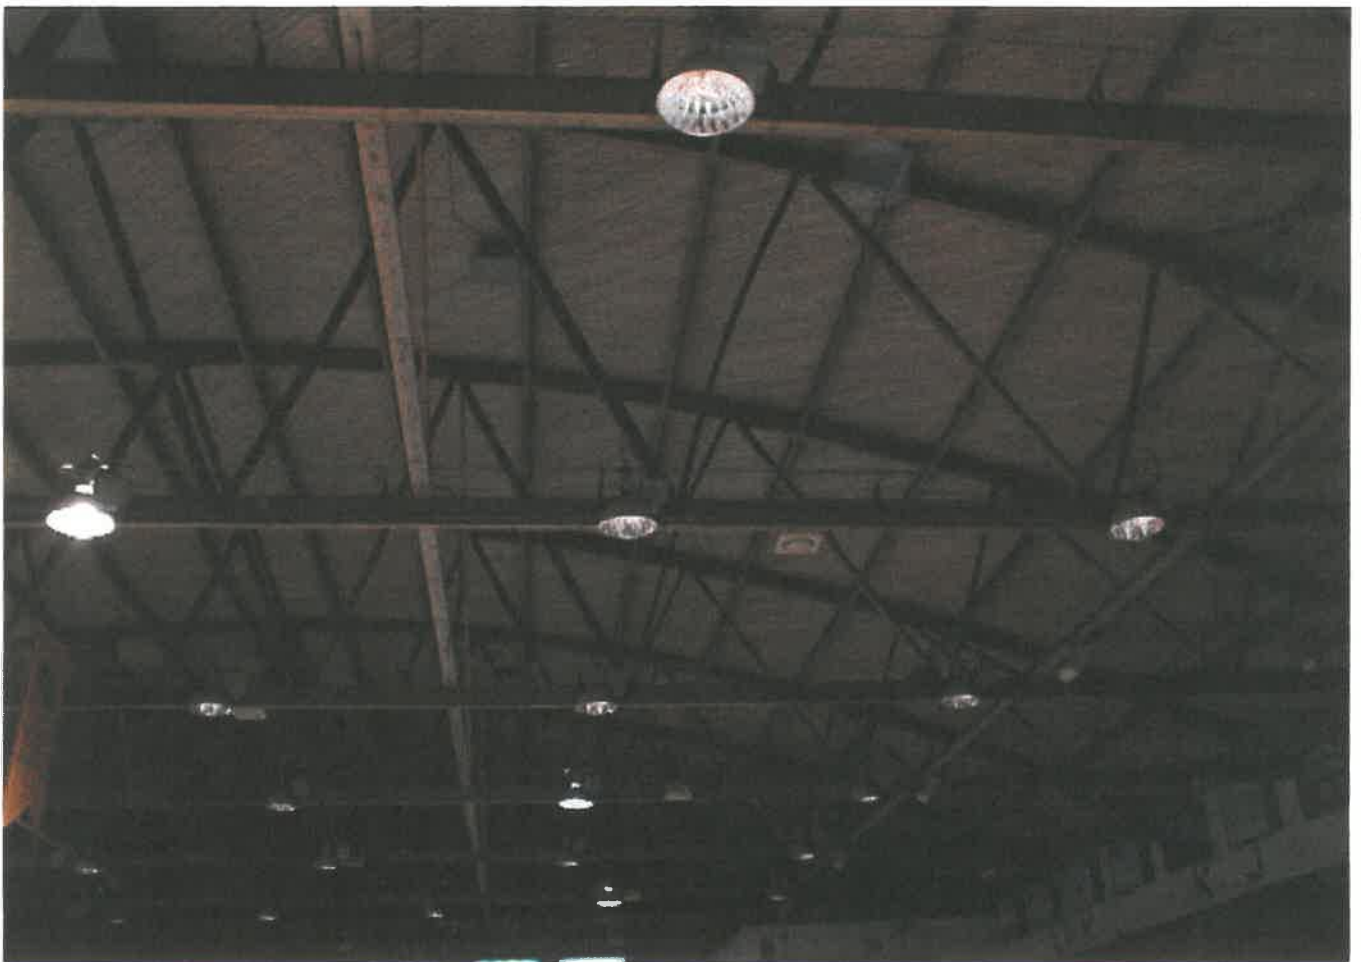
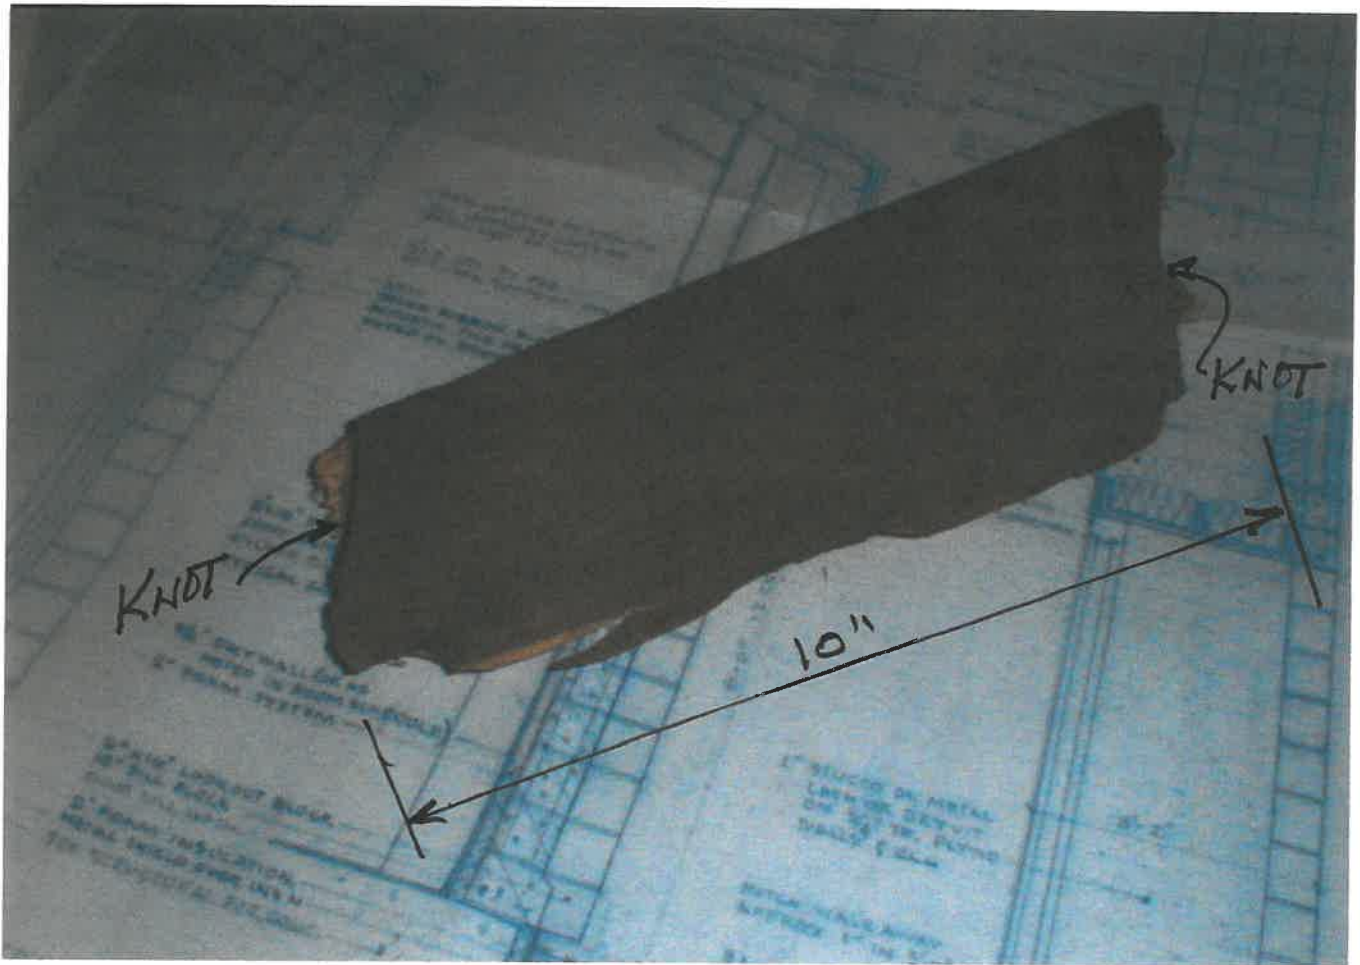
- 4.) The member that did fracture had a knots at two points of the fracture on a large piece found on the ice surface (see Appendix A, page A2). These knots further reduced the member's strength, hence the cause of the failure.

From the interior, we observed a very visible bowing or lateral deflections of several of the web members in the vertical plane of the arch trusses (see attached photos in Appendix A). **The fifth truss from the north end had a broken member located just above the third bottom chord panel point from the east end.** The most severely bowed members were located at the same relative position, about 40 feet west of the east bearing, on several of the adjacent trusses.

With the effort of Hawk Construction in collaboration with the Grand Rapids Public Utilities Department, on very short notice the broken member was replaced with a temporary 4" x 4" post and three of the other most bowed diagonals were reinforced with screwed on 4 x 4 posts to stiffen each of them. The snow removal crew did a great job at relieving the unbalanced loading. Because of these efforts, we were able to allow the Ice Show to go on without danger of the roof being a hazard to the occupants. All of this work was completed within three hours of our receiving word of the problem. The Civic Center Maintenance staff, Hawk Construction and the Public Utilities department deserve commendation for their professional and expedient work.

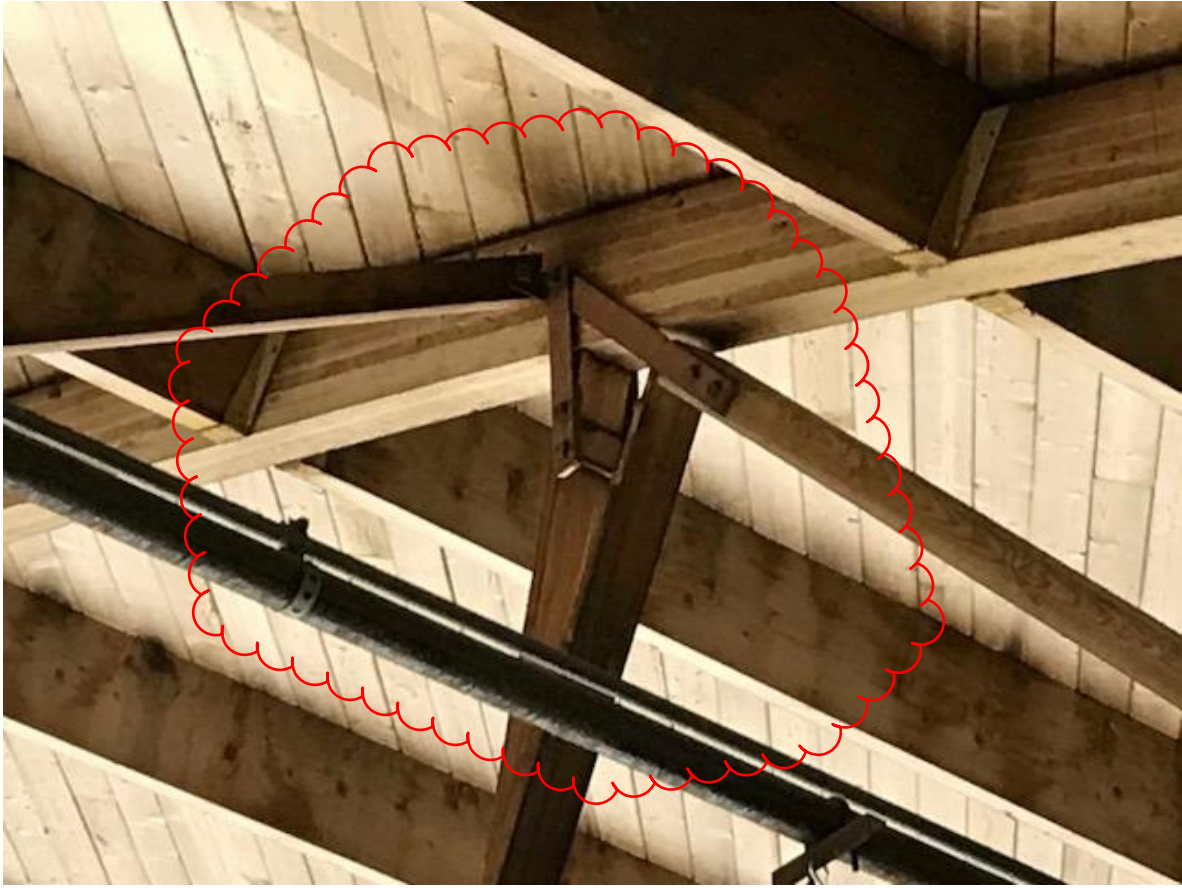
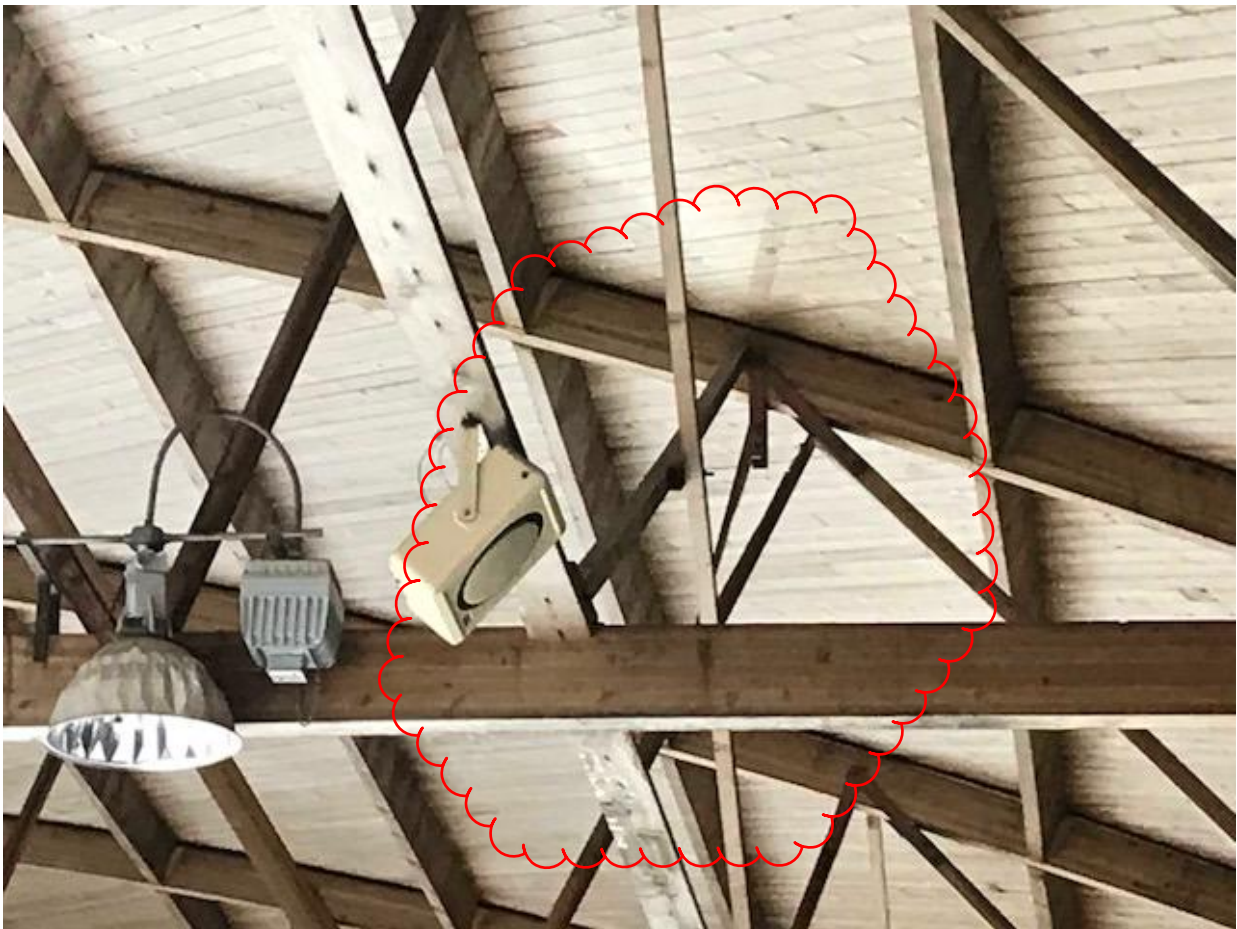
When we arrived, we walked the east bleachers and discovered a failed member of the 5th truss from the north end of the building. Based on our analysis, the failed member is one of the members most effected by an unbalanced loading condition.

After the meeting, we observed the roof snow loading from the adjacent roof and noted that only a few inches of snow appeared to be on the roof. We also observed the truss again and noted that the adjacent web members were bowed significantly and appear to be in danger of failure. We directed the Manager to close the West Venue and to shore the truss.

1. Shoring: The top and bottom chord of the truss should be supported from the ground surface until the repair is made. It is not sufficient to shore only the bottom chord.

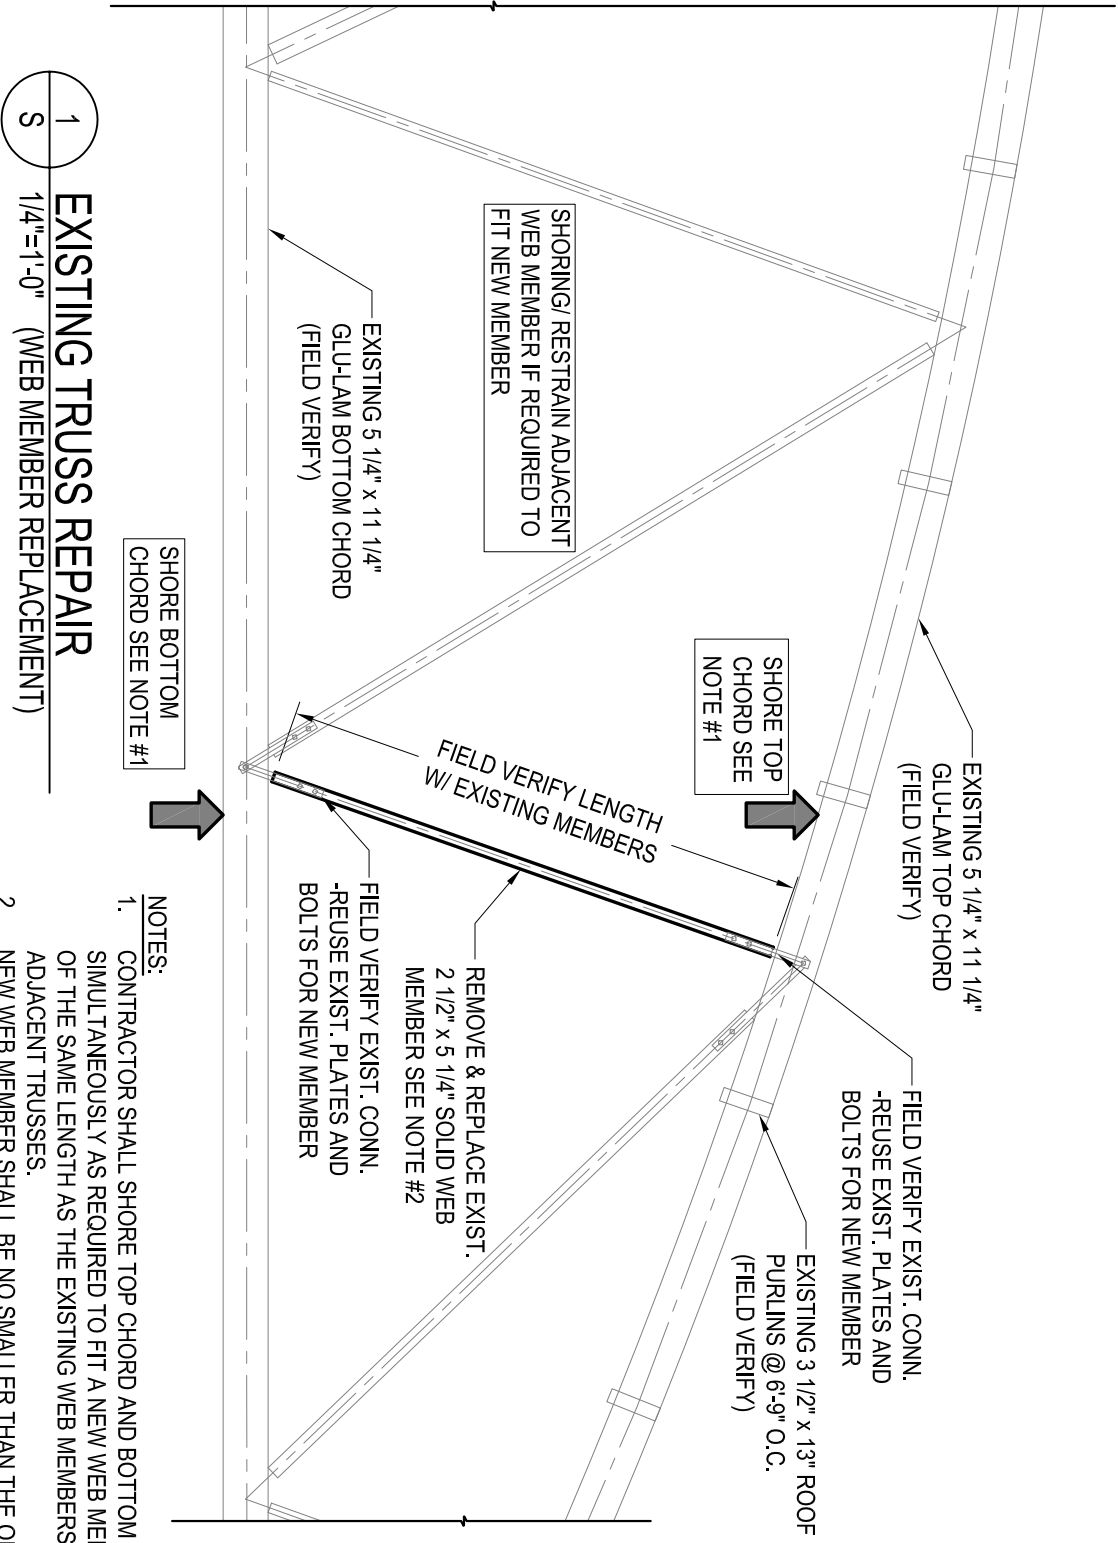
1
EXISTING TRUSS REPAIR
 1/4"=1'-0" (WEB MEMBER REPLACEMENT)

Based on our discussions and further review of the failure. We determined that the new web failure did occur in the same truss as a previous failure and repair in 2001. We also noted that the previous failure was in an adjacent web member. Since it is possible that the diminished capacity of the member could also be due to incorrect procedures in the previous repair, we informed the building official and staff of this possibility. This information along with their internal discussions and planning has apparently led them to instruct NCE to provide a repair detail for the broken web member.

Attached to this letter, please find our repair detail for the failed member. In our opinion, it is possible that this failure is partially due to improper repair in the past, but it is also possible that the failure under light loading is partially or completely due to reduced capacity due to long term moisture changes. Therefore, as we discussed, in our professional opinion:

SHORE BOTTOM
 CHORD SEE NOTE #1
